DEPARTMENT OF TRANSPORTATION

Contract #: 04-0120F4Cty: SF/ALA Rte: 80 PM: 13.2/13.9File #: 69.28**WELDING INSPECTION REPORT****Resident Engineer:** Pursell, Gary**Address:** 333 Burma Road**City:** Oakland, CA 94607**Report No:** WIR-001508**Date Inspected:** 04-Feb-2008**Project Name:** SAS Superstructure**OSM Arrival Time:** 700**Prime Contractor:** American Bridge/Fluor Enterprises, a JV**OSM Departure Time:** 1500**Contractor:** Zhenhua Port Machinery Company, Ltd (ZPMC), Changxing Island **Location:** Shanghai, China

Bridge No: 34-0006**Component:** Tower Mock-ups and OBG**Summary of Items Observed:**

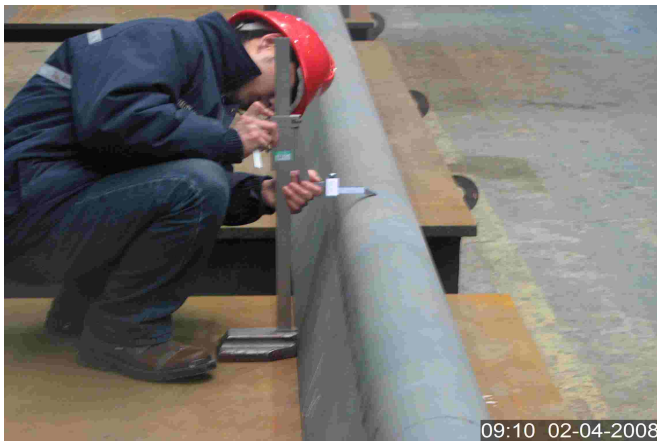
attempt to measure the height of the closed ribs. The Quality Assurance Inspector observed ZPMC using a caliper type device to measure the height of the ribs providing a more accurate value. Below is a digital photograph illustrating the device.
